Company Name	Date	PI/PO No.	Item No.	Failure Quantity	Production Code (printed on the jacket of light)
科利尔企业 (勿动)	2022-10-24 14:54:43		C-FR-F22	2	C-FR-F22

1. Defects Description

III Root Cause of Defective Owner & Due Date : Brook

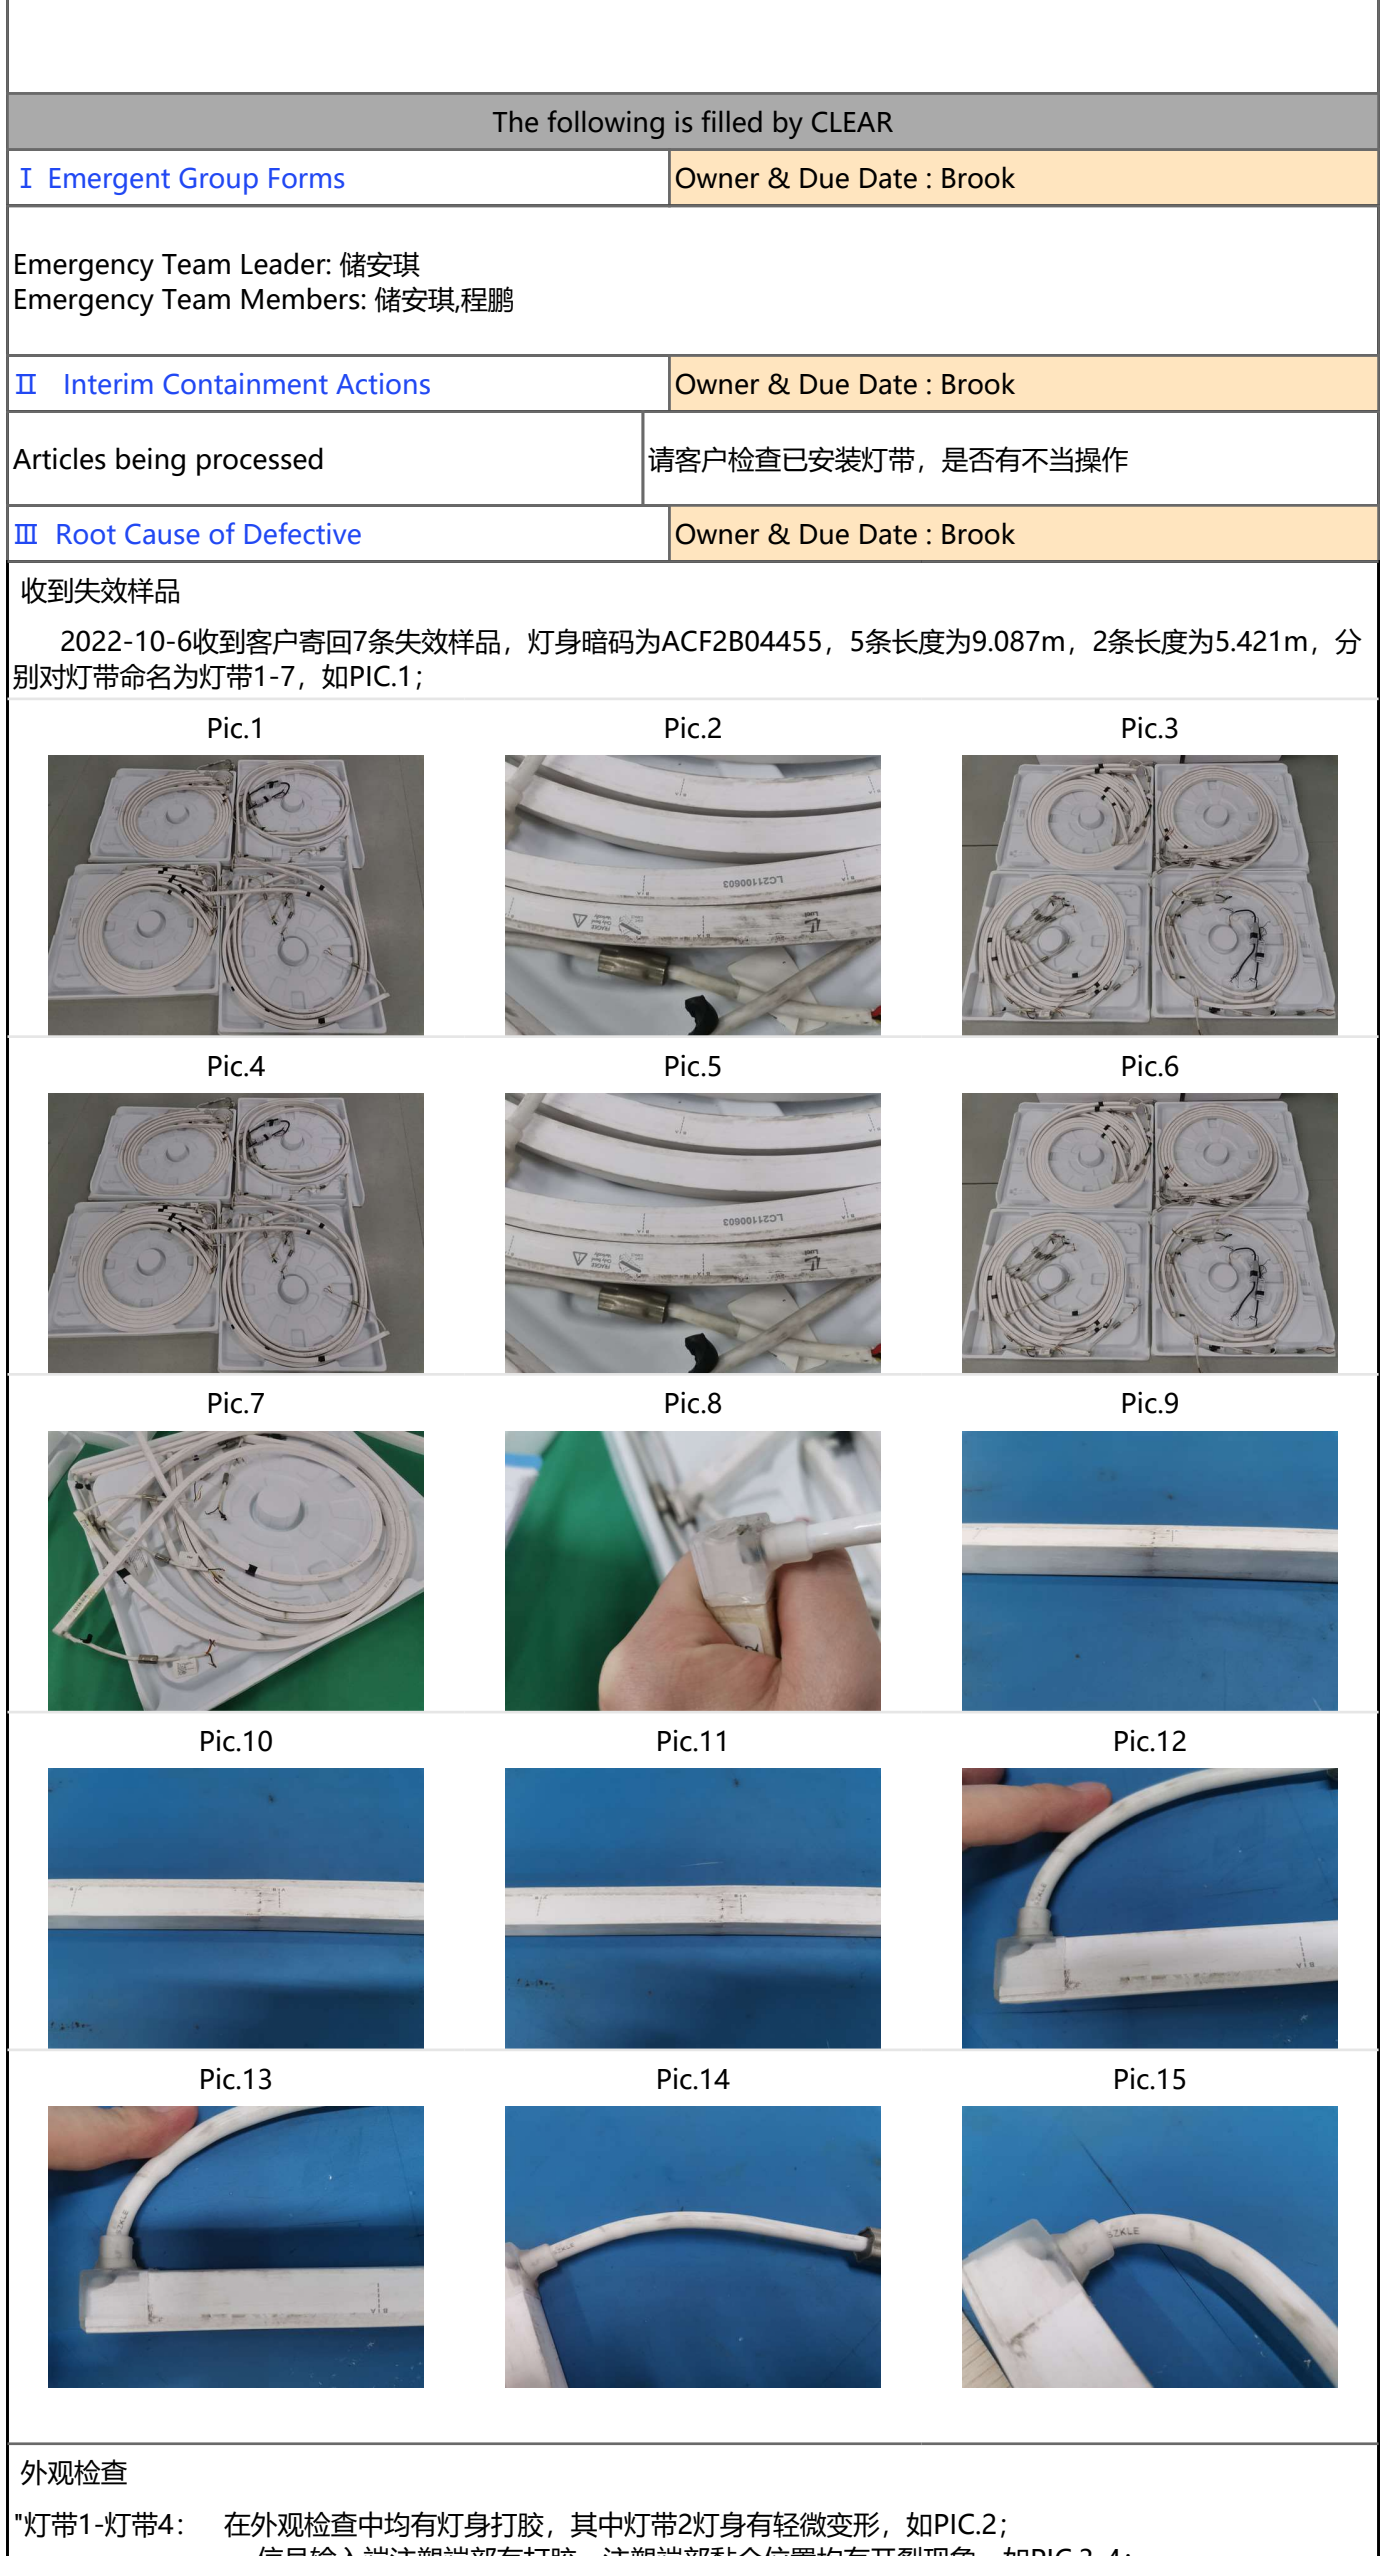
收到失效样品

2022-10-6收到客户寄回7条失效样品, 灯身暗码为ACF2B04455, 5条长度为9.087m, 2条长度为5.421m, 分别对灯带命名为灯带1-7, 如PIC.1;

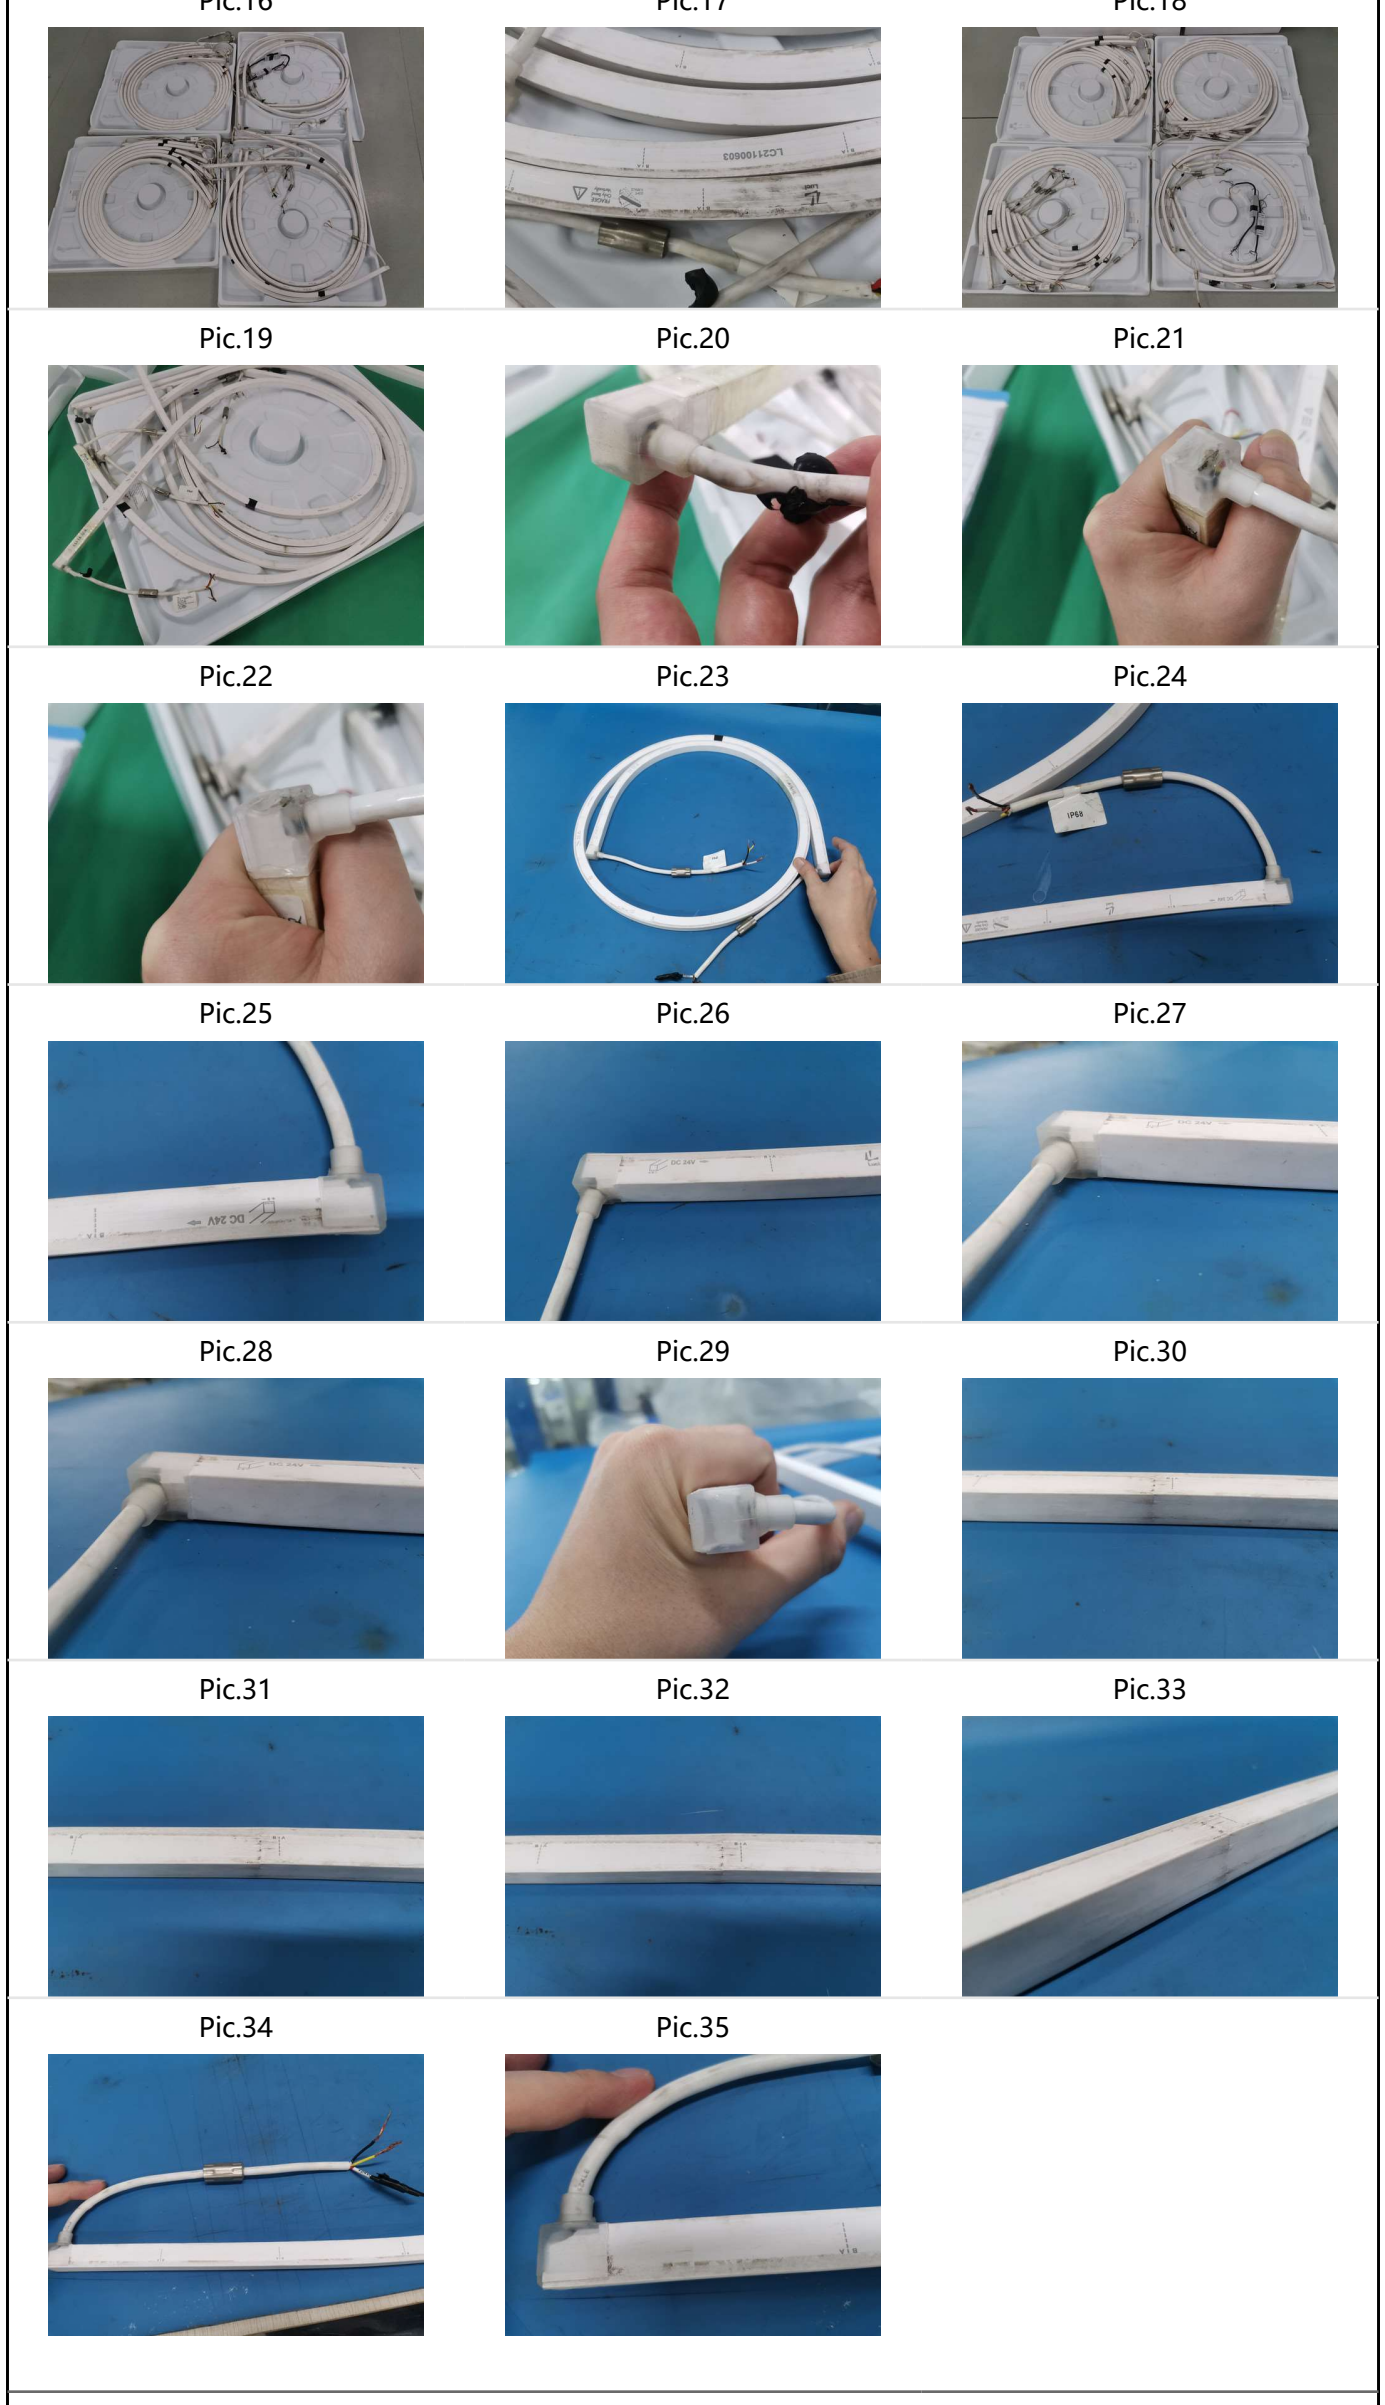
外观检查

*灯带1-灯带4: 在外观检查中均有灯身打胶, 其中灯带2灯身有轻微变形, 如PIC.2; 信号输入端注塑端部有打胶, 注塑端部黏合位置均有开裂现象, 如PIC.3-4; 灯身有不同程度的鼓包及朝侧面翘起现象, 如PIC.5-6;

灯带1-4失效是因进水导致, 结合外观检查, 灯身及注塑端部有打胶固定, 结合过往经验及验证, 灯带注塑端部被结构胶固定住, 灯带在进行热胀冷缩机理收缩时与结构胶之间产生拉力, 导致注塑部位开裂, 使灯带防水等级降低, 水沿着开裂位置进入灯带内部失效;

1. 建议客户安装时请勿将注塑部位固定住, 避免灯带在进行热胀冷缩机理收缩时与结构胶之间产生拉力造成注塑部位开裂, 如需打胶固定, 请将灯带注塑部位的发光面也一起使用胶覆盖固定, 覆盖长度约10mm, 且需要注意所使用胶的材质。
--- 责任人: 营销

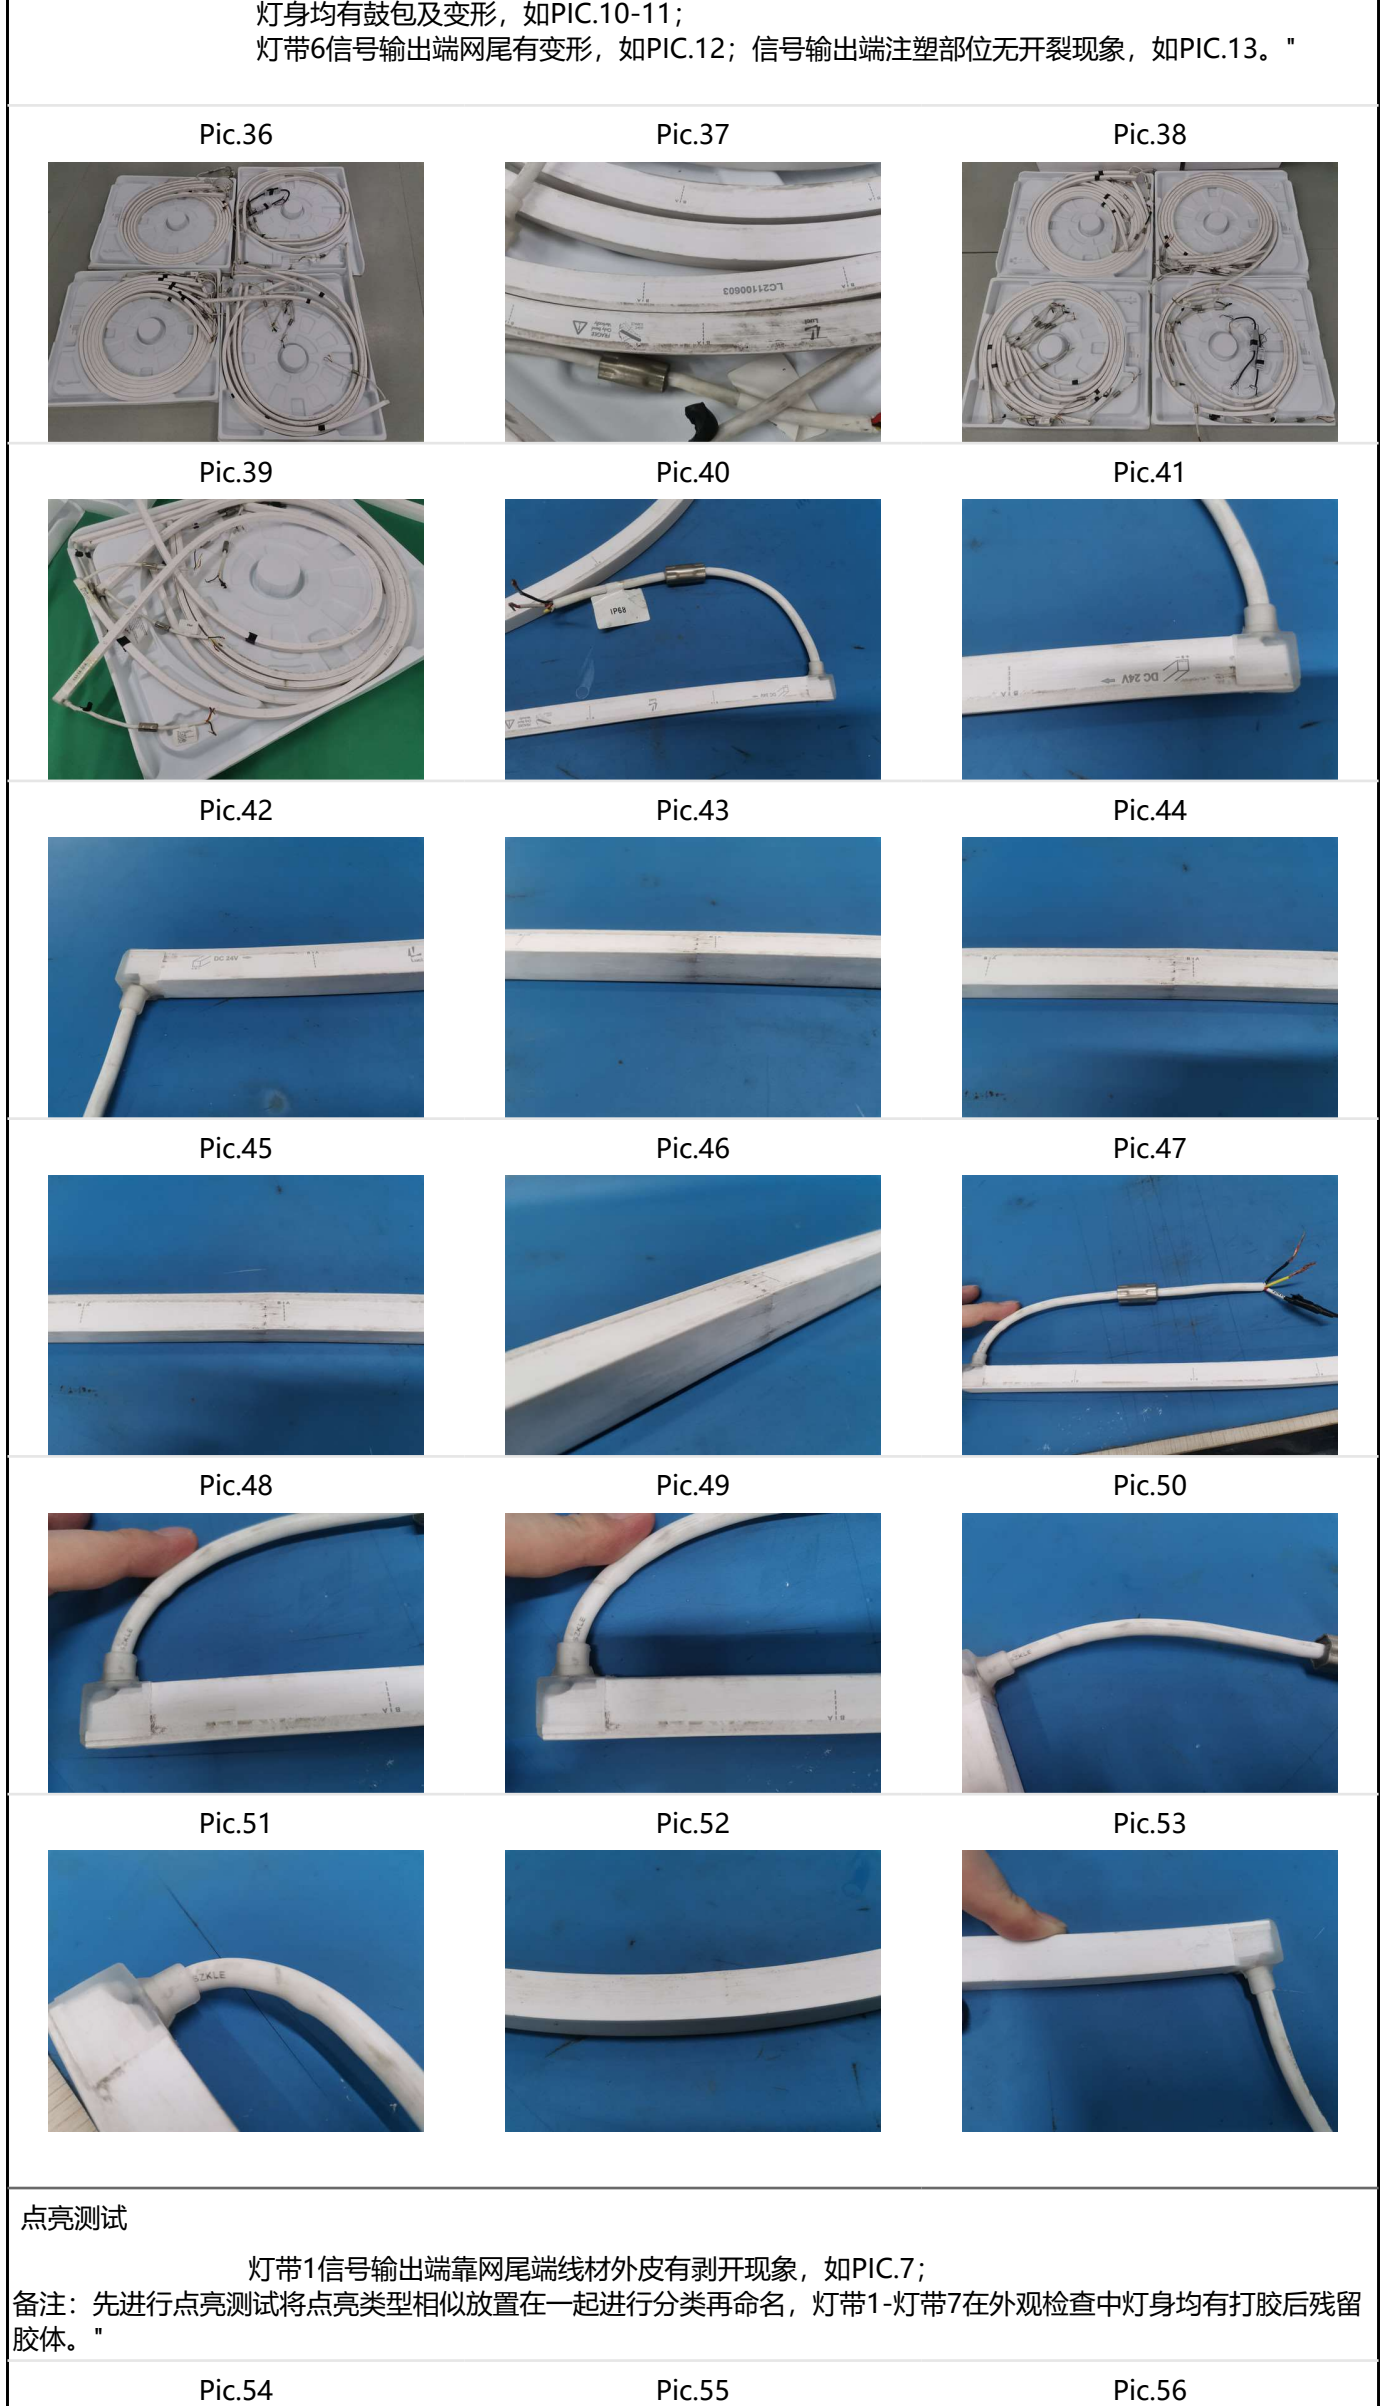
外观检查

*灯带5-灯带7: 灯带5及灯带7信号输入端朝侧面翘起, 如PIC.8-9; 灯身均有鼓包及变形, 如PIC.10-11; 灯带6信号输出端网尾有变形, 如PIC.12; 信号输出端注塑部位无开裂现象, 如PIC.13. *

灯带5-7失效是因PCBA断裂导致, 结合外观检查及解剖分析, 该正弯灯带在安装使用过程中有扭曲及朝两侧弯曲现象, 导致PCBA产生褶皱及损伤, 在后续使用过程中导致PCBA断裂。*

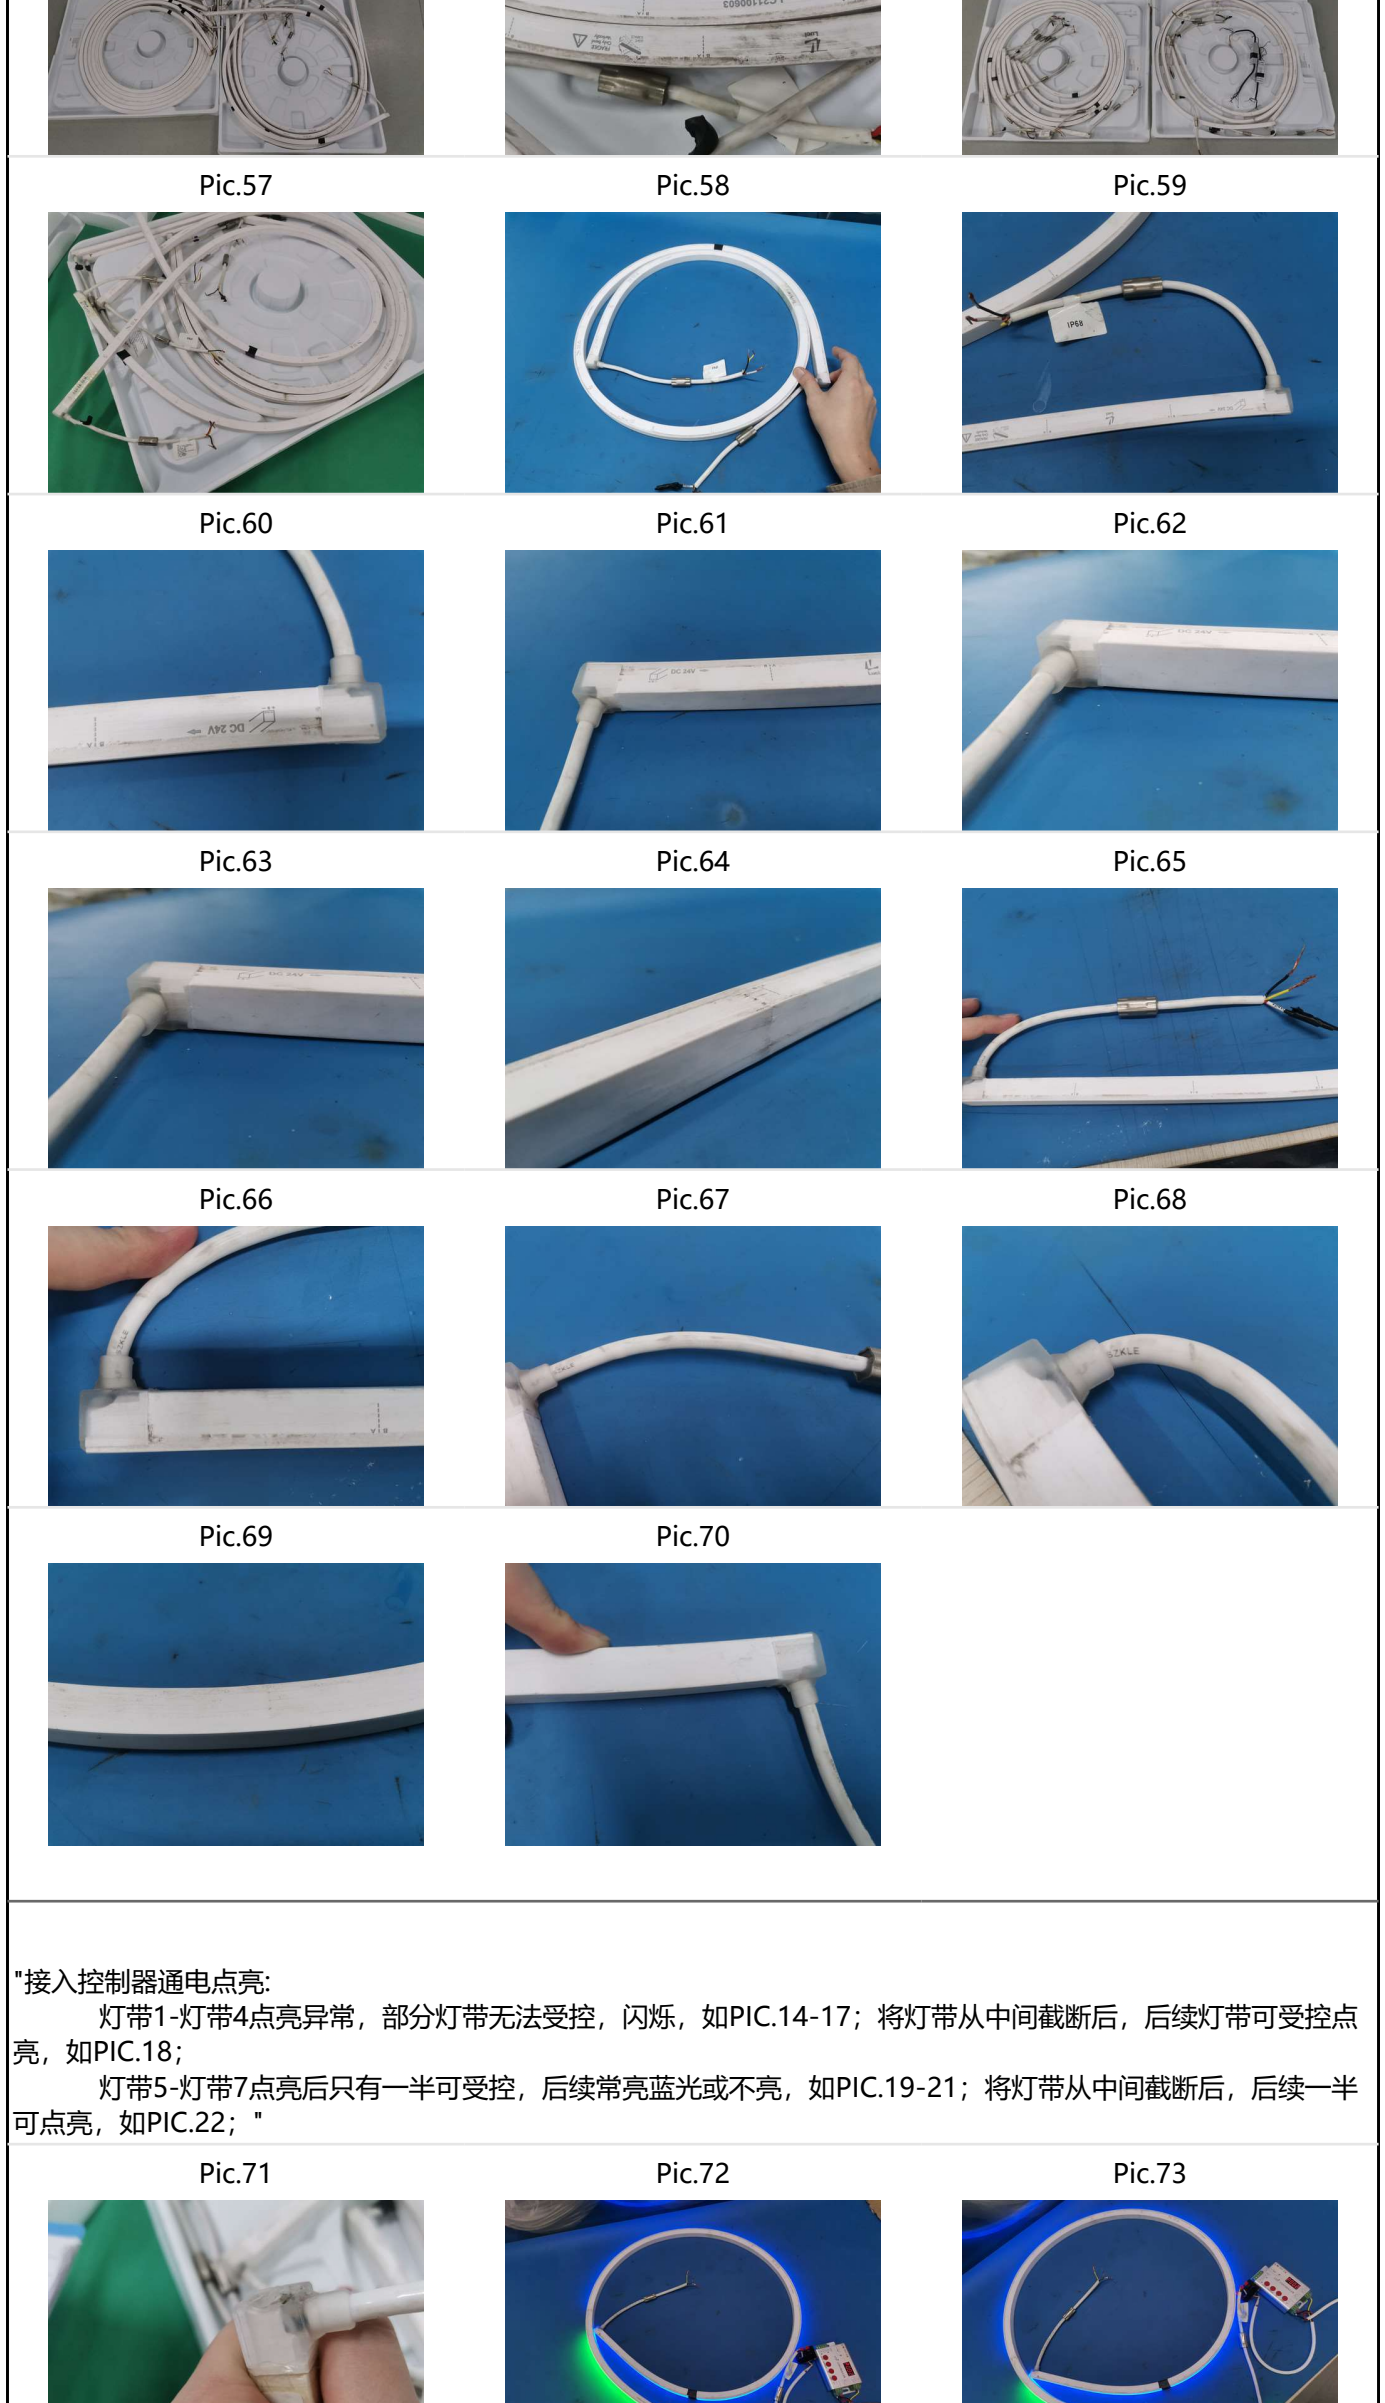
点亮测试

灯带1信号输出端靠网尾端线材外皮有剥开现象, 如PIC.7;

备注: 先进行点亮测试将点亮类型相似放置在一起进行分类再命名, 灯带1-灯带7在外观检查中灯身均有打胶后残留胶体. *

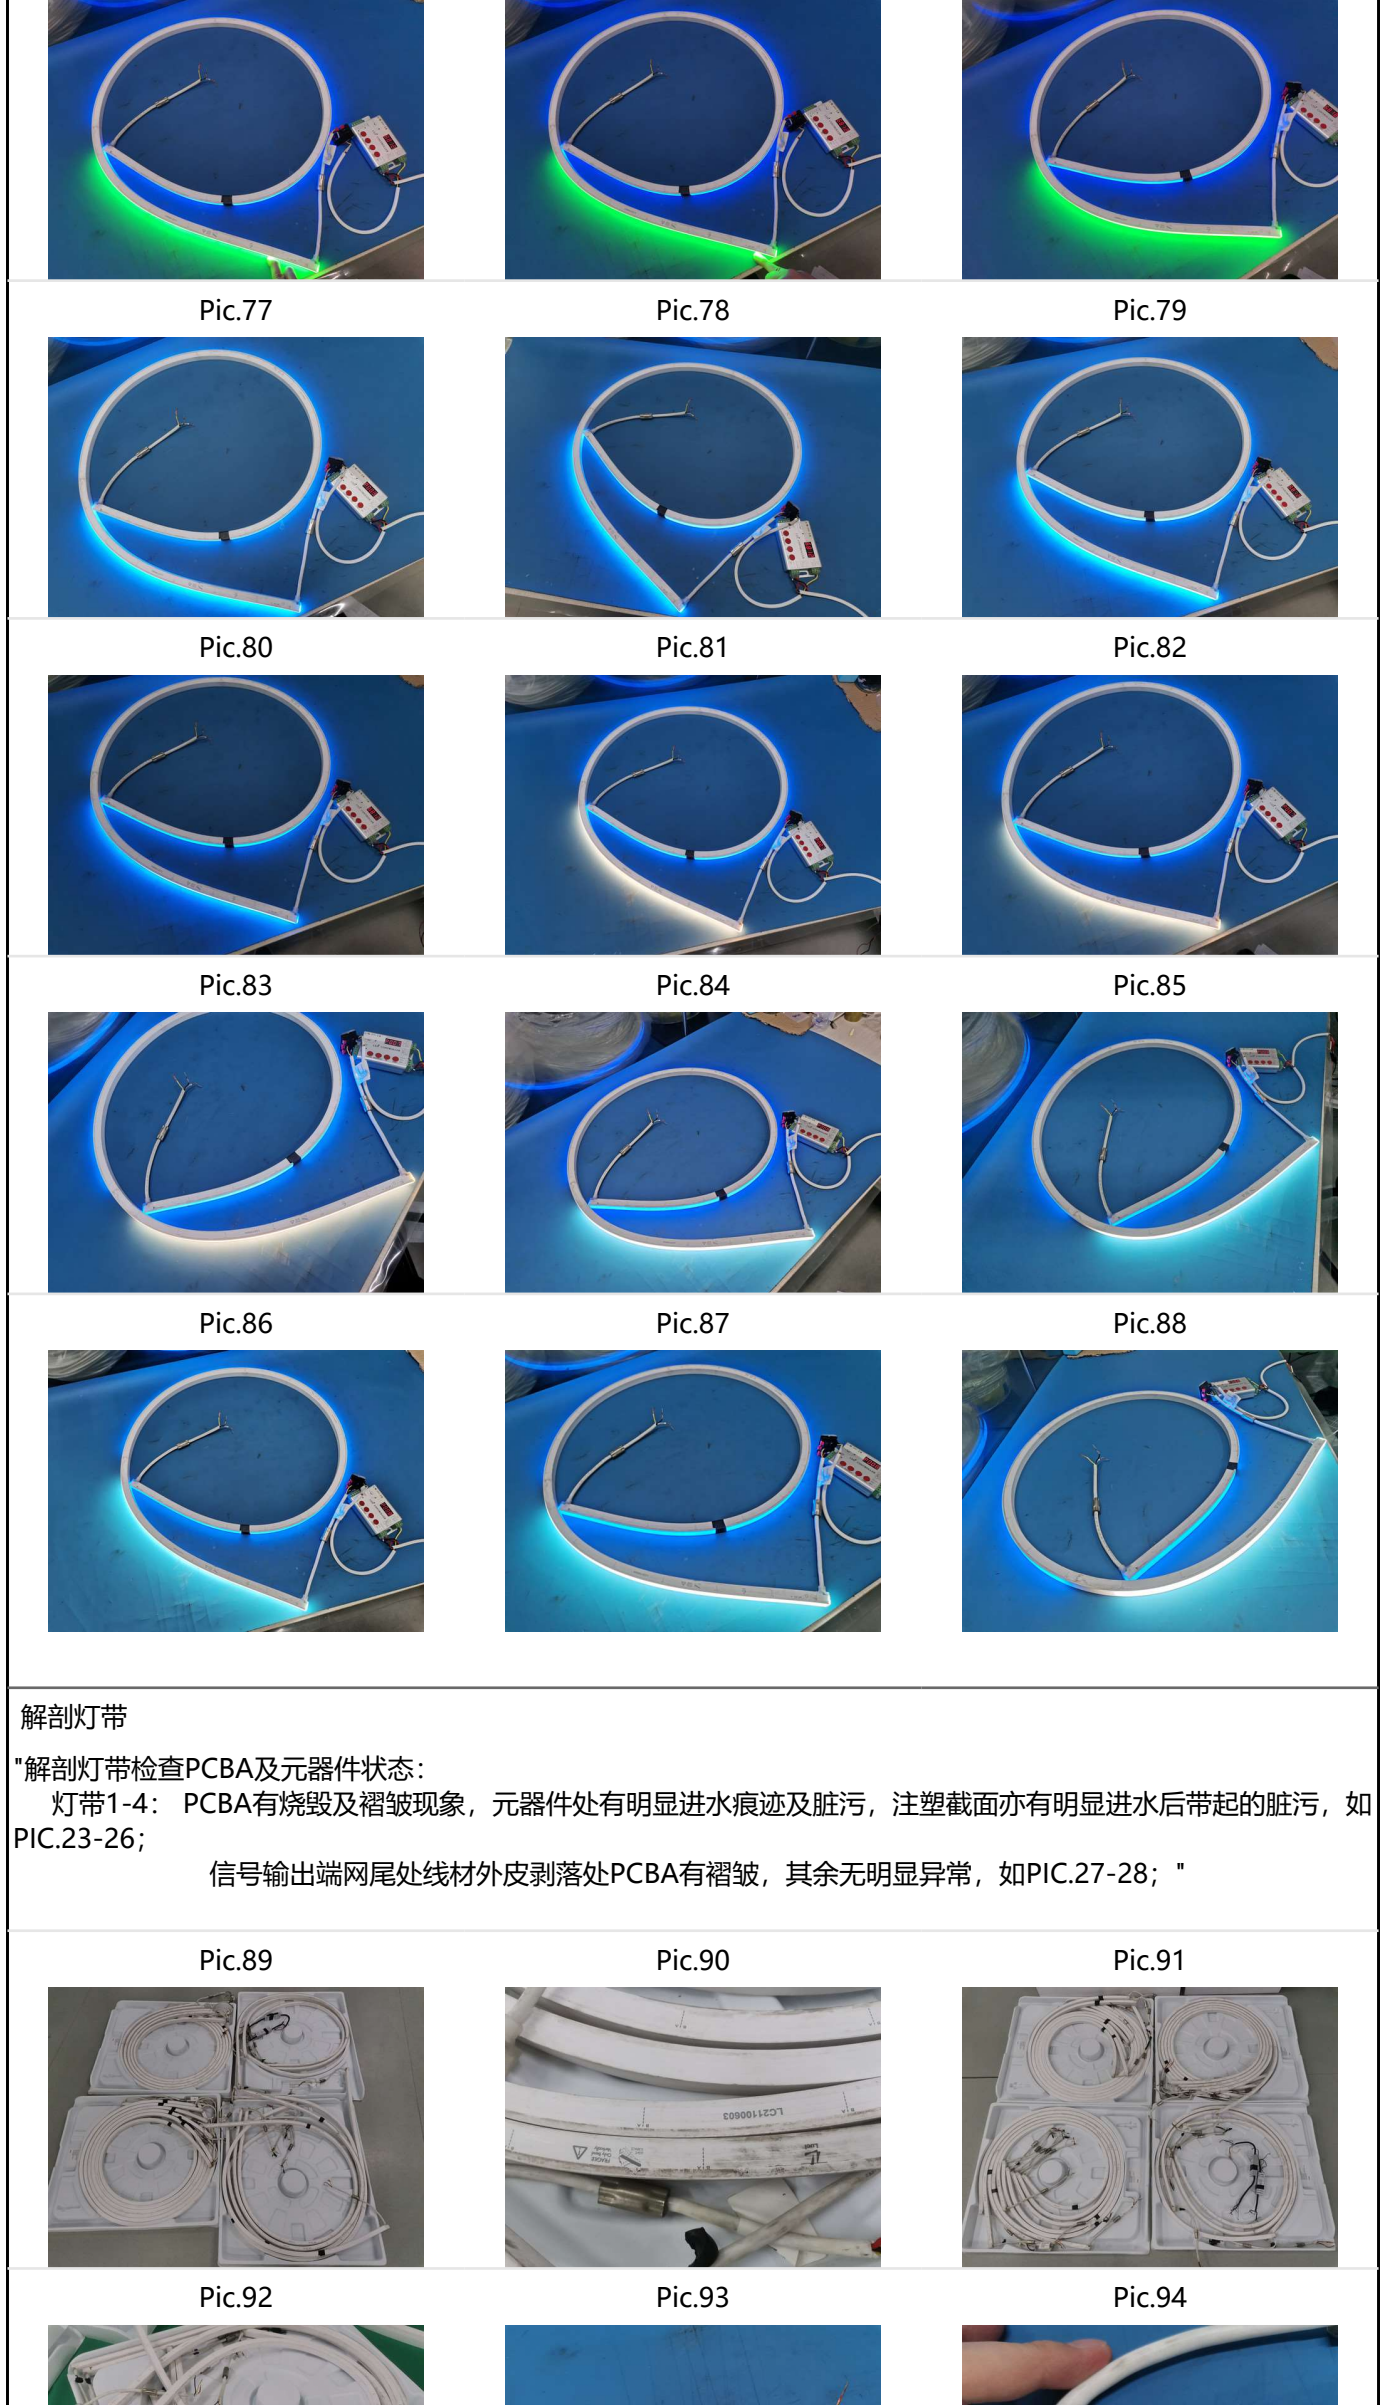
灯带1-灯带4点亮异常, 部分灯带无法受控, 闪烁, 如PIC.14-17; 将灯带从中间截断后, 后续灯带可受控点亮, 如PIC.18;

灯带5-灯带7点亮后只有一半可受控, 后续常亮蓝光或不亮, 如PIC.19-21; 将灯带从中间截断后, 后续一半可点亮, 如PIC.22; *

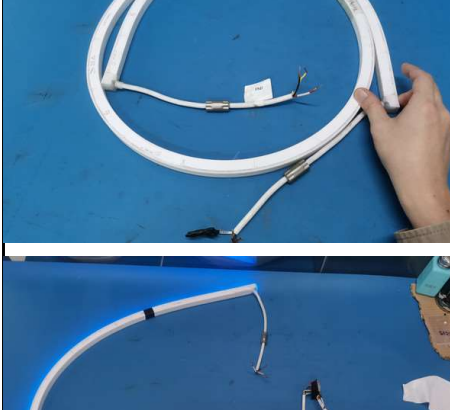
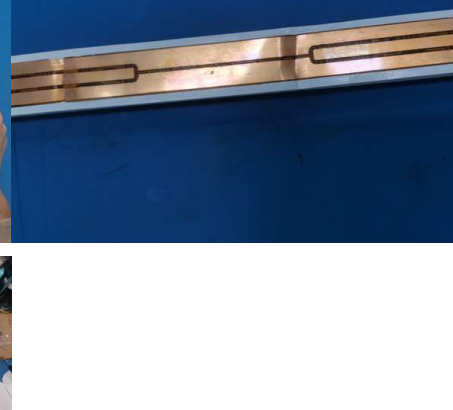
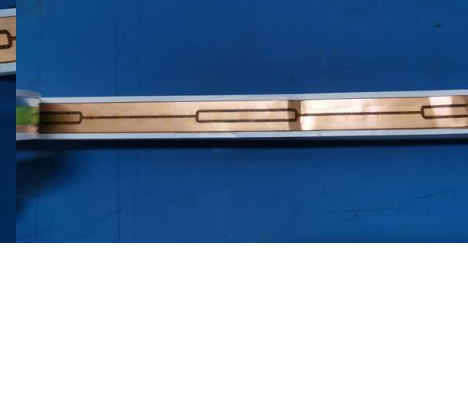
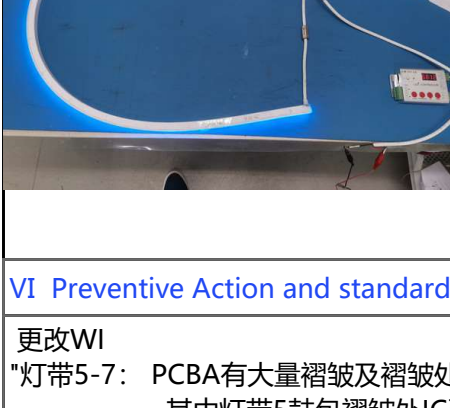
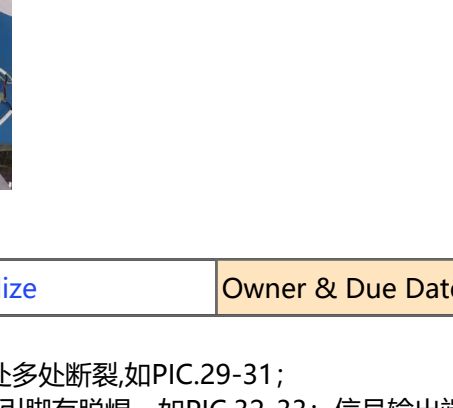
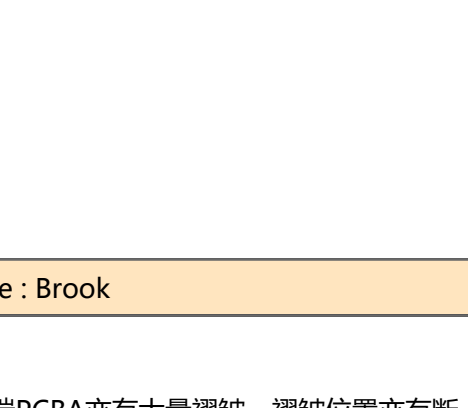
*灯带5-7: PCBA有大量褶皱及褶皱处多处断裂如PIC.29-31;

其中灯带5鼓包褶皱处IC引脚有脱焊, 如PIC.32-33; 信号输出端PCBA亦有大量褶皱, 褶皱位置亦有断裂, 如PIC.34。*
